Caltrans Division of Research, Innovation and System Information

FEBRUARY 2015

Repair of Earthquake-Damaged Columns with Fractured Bars

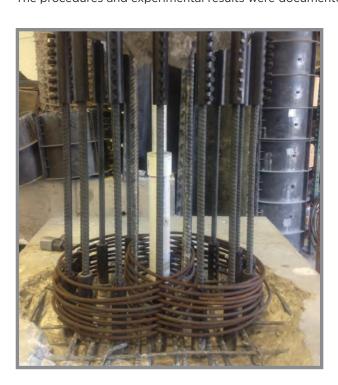
Column R-Calt-1 with couplers and new replacement longitudinal bar segments in place

The two columns repaired with mechanical bar couplers in the plastic hinge region did not sustain damage during the test, indicating that this method restores the column's strength and deformation capacity. Both types of couplers were effective. The column that was repaired with externally bonded prefabricated CFRP strips and jacket was also able to restore the column strength and deformation capacity without requiring replacement of the internal reinforcement.

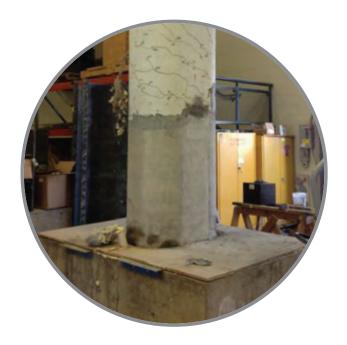
R-Calt-1 after concrete repair
